Crack growth in shot peened Al 7050 and 7075 alloys

PI: James E. Locke
Co- PI: Brijesh Kumar

- The main objective of the research is to determine the growth rates of short cracks through the thin zone of residual stresses created as a result of surface treatments such as shot peening
 - Several specimen types were investigated
 - There is little experimental data in the open literature about fatigue crack growth in materials which are surface treated using shot peening

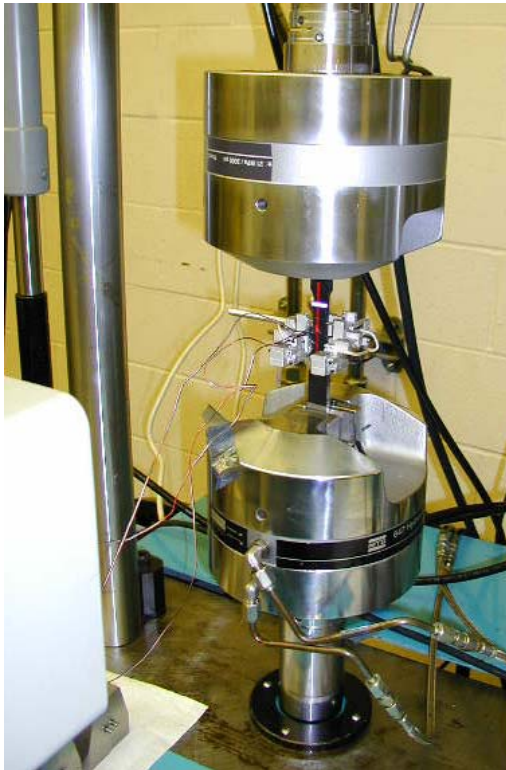
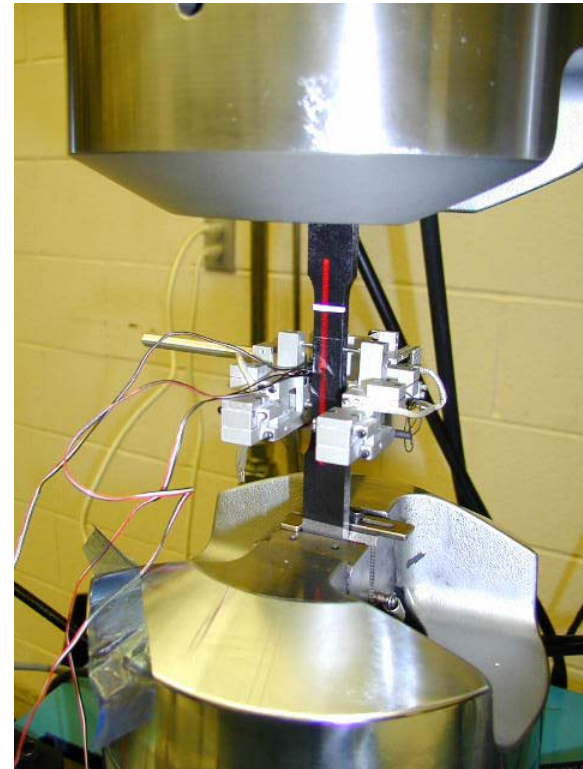
- Tensile test were monitored using the following equipment
 - Laser extensometer
 - To provide the total extension of the gage section
 - Bi-axial Extensometer
 - To determine the Poisson's ratio and axial displacement in the linear region
 - Strain gages
 - Gages capable of measuring 20% strains were used
 - 0° and 90° were used results verified with the Bi-axial extensometer
